**EVALUATION OF AIRCRAFT WINDSHIELD MATERIALS
IN A SIMULATED SUPERSONIC FLIGHT ENVIRONMENT**

J.B. HOFFMAN
Douglas Aircraft Company
McDonnell Douglas Corporation
3855 Lakewood Boulevard
Long Beach, California 90846

JUNE 1979

TECHNICAL REPORT AFFDL-TR-79-3058

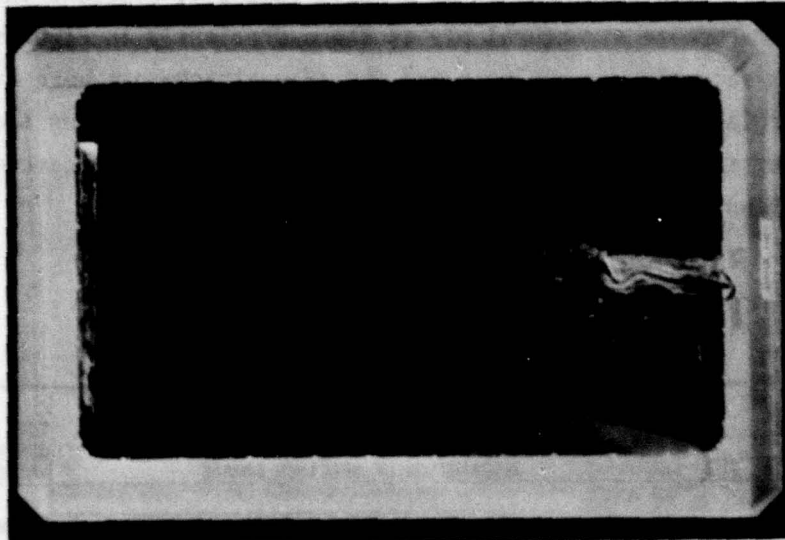
Figure 31. Post-Test Photo of Specimen SK05.

GY01 was tested. SK06 and GY01 were previously subjected to a temperature of 250°F as part of an abrasion test (Reference 9). These three specimens sustained delamination of the face ply from the interlayer during the last seconds of tunnel injection and were considered to have failed. Specimen SK05 survived Mach 2.4 test but failed at Mach 3.0. Specimen SK06 and GY01 failed at Mach 2.6. The delamination of SK06 began in the area of the imbedded thermocouple at Mach 2.6. The delamination of SK05, Figure 31, and GY01, Figure 32, began near the aft edge and spread forward. The direction of air flow in these figures was left to right and aft edge is at the right side of the figure. The polycarbonate along the aft edge of both specimens bubbled and protruded about 0.10-inch. The material expanded until it contacted the forward face of the simulator cover (Figure 13, Page 19).

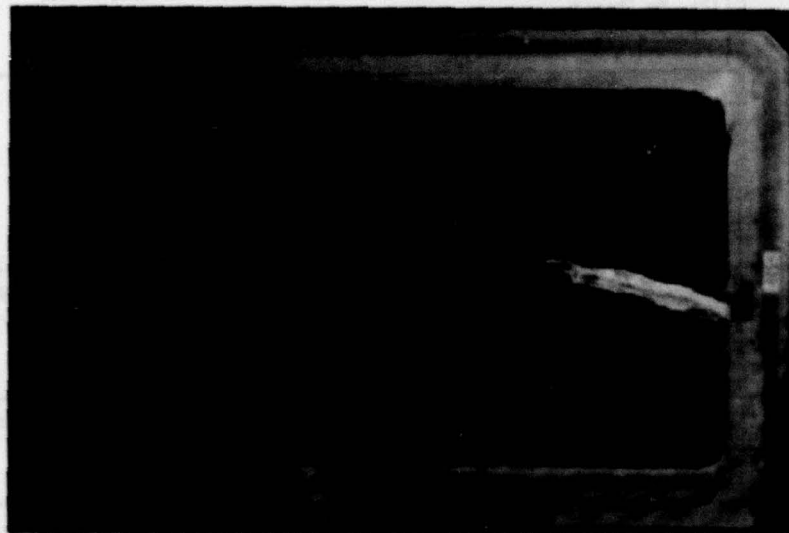
Figure 32. Post-Test Photo of Specimen GY01.

(2) GY01 was previously tested (Reference 1) for 20 minutes at Mach 2.0 and 10 minutes at Mach 2.2. No damage was reported.

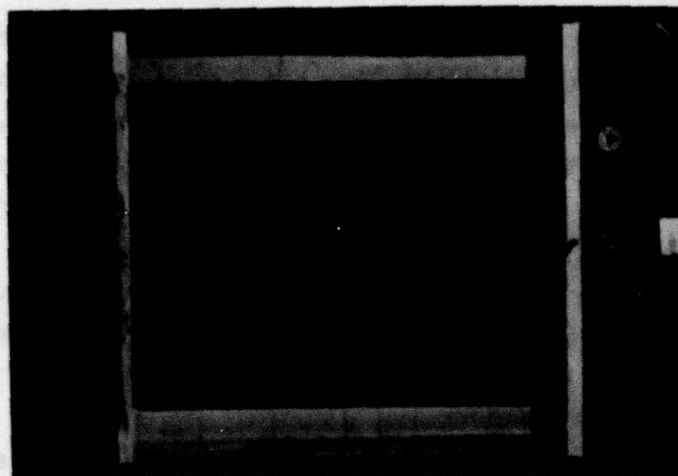
Figure 35. Post-Test Photo of Specimen SWU21.

Specimen SWU21, Figure 35, was tested at Mach 2.4, 2.6 and 3.0. This specimen sustained erosion and discoloration of the groove sealant. The discoloration appeared to be residue from the fiberglass. The sealant remained pliable.

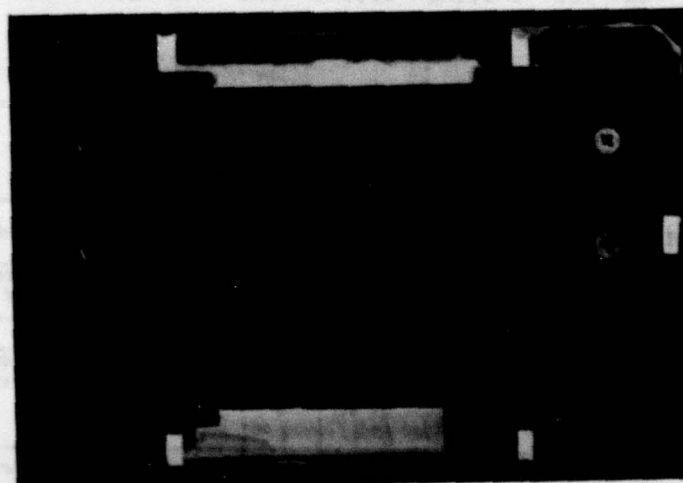
Figure 36. Post-Test Photo of Specimen SWU22.

Specimen SWU22, is shown in Figure 36. This specimen suffered delamination during its second injection at Mach 2.6. The delamination began in the area of the imbedded thermocouple. No erosion occurred under the fiberglass retainer.

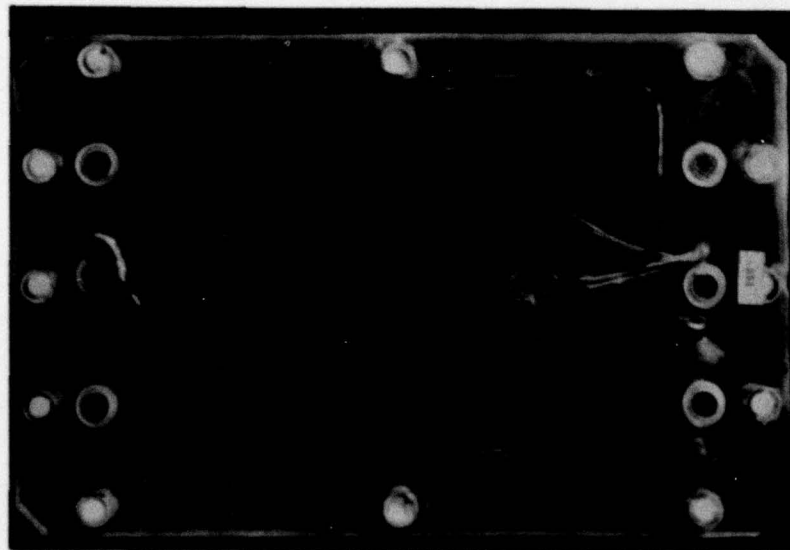
Figure 41. Post-Test Photo of Specimen GY25.

An examination of GY25, Figure 41, revealed slight face ply/interlayer delamination in the area of the imbedded thermocouples after the first injection at Mach 2.4. Severe delamination occurred during the second injection.

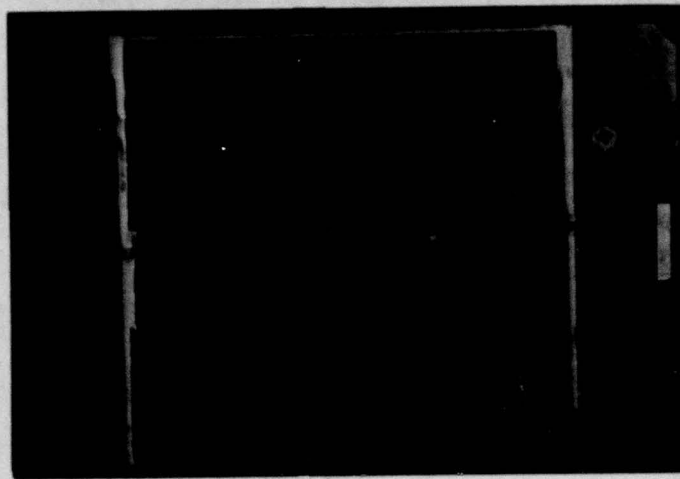
Figure 44. Post-Test Photo of Specimen SK23.

Specimen SK23 is shown in Figure 44. This specimen, tested at Mach 2.6 and 3.0, sustained bubbling and deformation of the polycarbonate structural ply along the aft edge. The flatness of the deformed area indicates that this surface was in direct contact with the simulator cover's aft edge. The adhesive that bonds the aft fiberglass edge members, consisting of two sheets, melted and oozed out from between the two pieces of fiberglass. The sealant in the groove between the edge of the glass and fiberglass edge member was discolored. The discoloration was easily removed and is apparently residue from the fiberglass edge member.

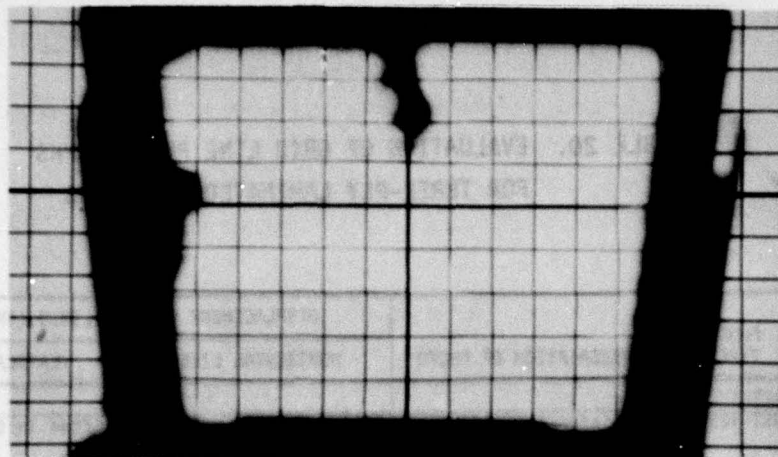
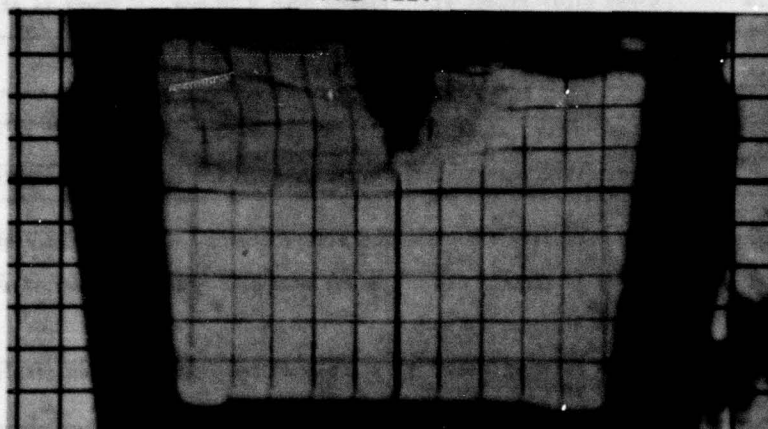
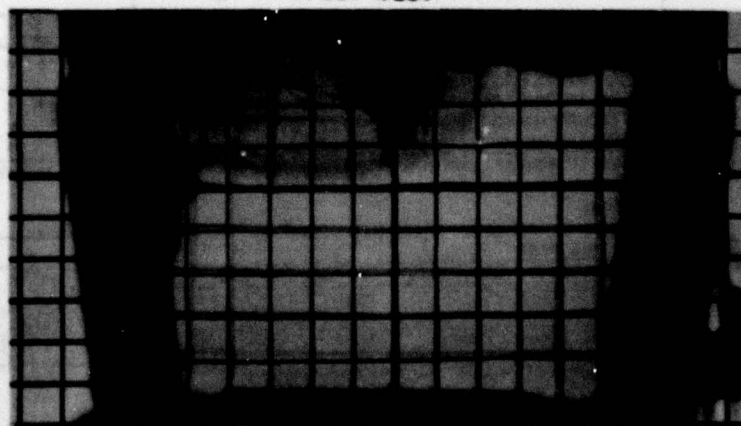
Figure 49. Grid Board Photos for Specimen SK05.

Figure 49 shows grid board photos of Specimen SK05 before and after tunnel testing, and an overlay of the two photos. Similar photos are shown in Figures 50, 51, 52, and 53 for Specimens SK06, SK21, SK22 and SWU21. The delamination suffered by SK05 is evident in Figure 49. Haze-ness is visible in all the pre-test photos and is seen by comparing the specimen surface with the lines beyond the frame of the specimen. The oval shaped hazy spot visible in SK06 (lower, center) was caused by an abrasion test (Reference 9). All specimens suffered distortion at the edges of the specimens. Slight line displacement is seen in the overlays.

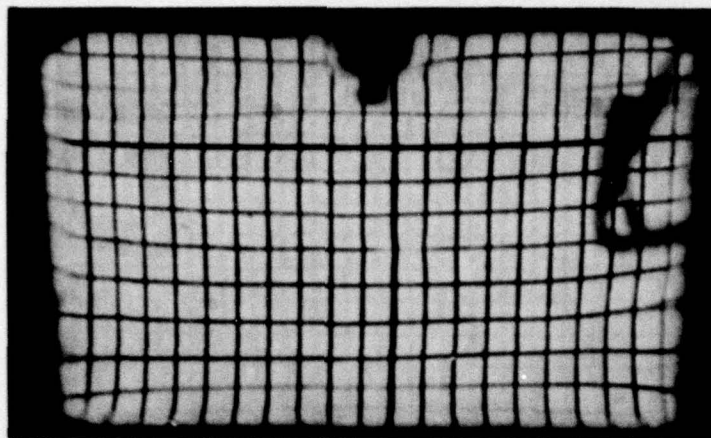
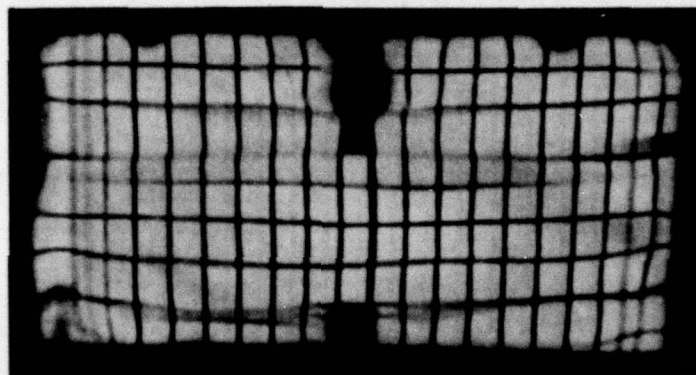
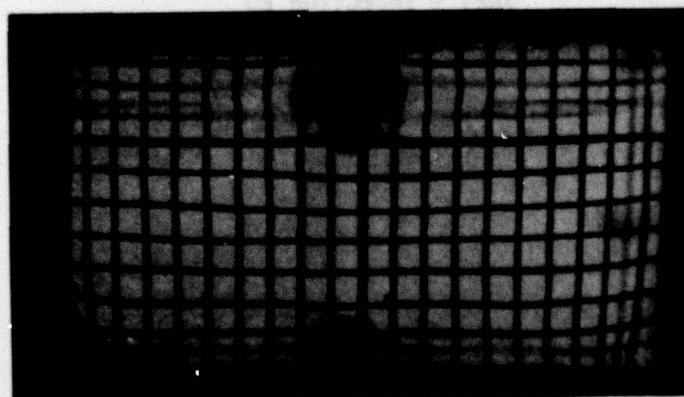
Figure 54. Tunnel Photos for Specimens SK05, SK21 and SHU21 at Mach 2.4 (10-Minute Injection).

The final tunnel photos and overlays for the Mach 2.4 injections are presented in Figures 54 and 55 for Specimens SK05, SK21 and SWU21. These were the last photos taken during the 10-minute injections. Specimen SK21 sustained more distortion than SK05 and SWU21. The cross section of SK21 and SWU21 were identical. Maximum line displacement is about 0.18 inch for the horizontal lines of SK21.

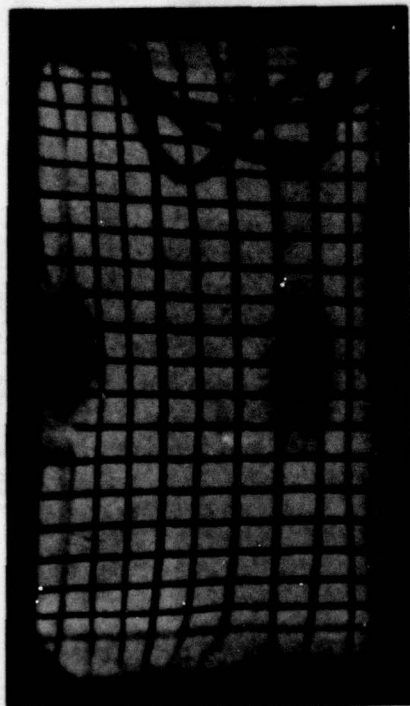
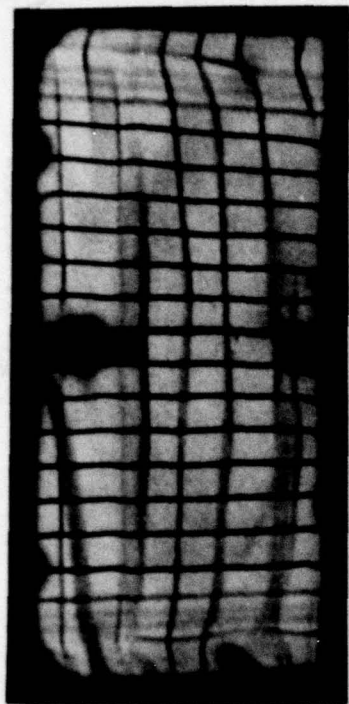
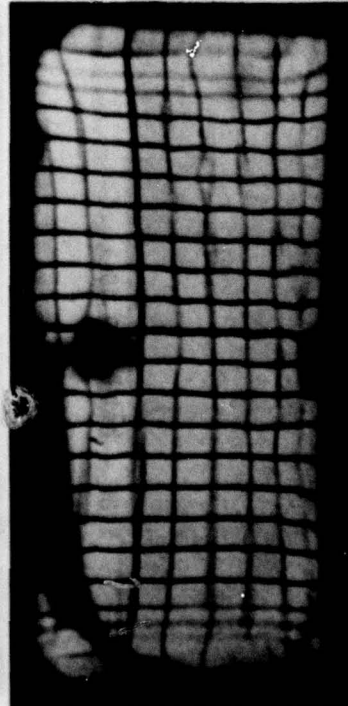
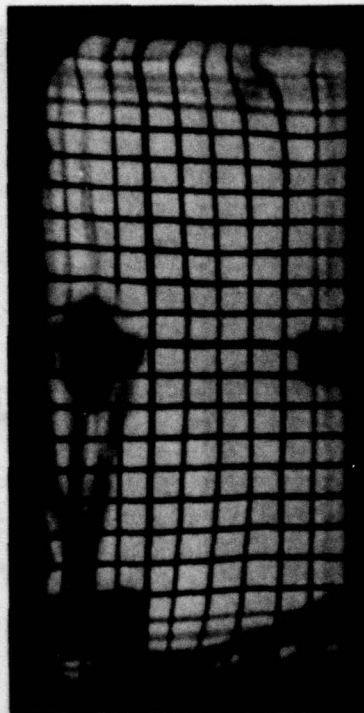
Figure 56. Tunnel Photos for Specimens SK06, SK21, SK22 and SMU21 at Mach 2.6 (10-Minute Injection).

Photos and overlays for the Mach 2.6 injections are exhibited in Figures 56 and 57 for the 10-minute injection of Specimens SK06, SK21, SK22 and SWU21. Specimen SK06 and SWU21 display the clearest line definition. Specimen SK06 shows the largest line displacement, 0.25 inch for its horizontal lines.

The acrylic/silicone/polycarbonate configuration is a viable candidate for aircraft windshields that will operate at the Mach 2.6 level, as evidenced by the clarity of the tunnel photos for Specimen SK06 and SWU21 (Figures 56 and 57). Some distortion did occur along each side. Line displacement was about 0.25 inch maximum for the horizontal lines. Specimen SK21 and SK22 did not fare well. The photos showed irregular lines, distortion and loss of clarity. Specimen SWU22 could not be evaluated because the application of thermal paint prevented light transmission.

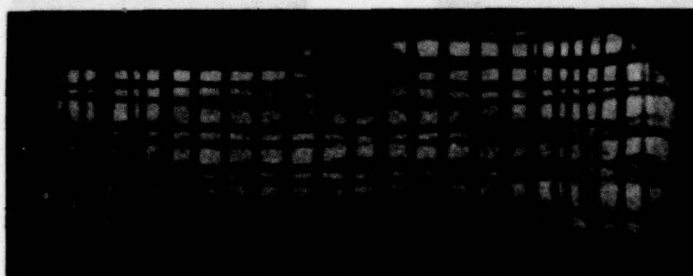
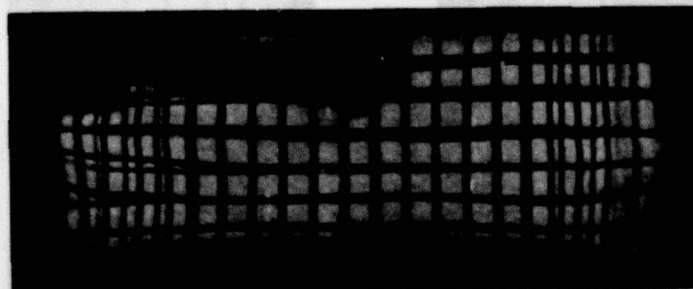
Figure 58. Tunnel Photos for Specimens SK05, SK21, SK22 and SMU21 at Mach 3.0 (3-Minute Injection).

Photos and overlays for the 3-minute injection of Specimen SK05, SK22 and SWU21 at Mach 3.0 are exhibited in Figures 58 and 59. The line quality is better for SK05 and SWU21 than for SK22. Line displacement for SK05 is 0.25-inch maximum for the horizontal lines.

The optical clarity of Specimen SK05 and SWU21 make the acrylic/silicone/polycarbonate configuration a potential candidate for Mach 3.0 aircraft (Figures 58 and 59). Further studies are needed to define the cause of optical degradation experienced by similar specimens, SK21 and SK22. Specimen SWU22 could not be evaluated due to the application of thermal paint.

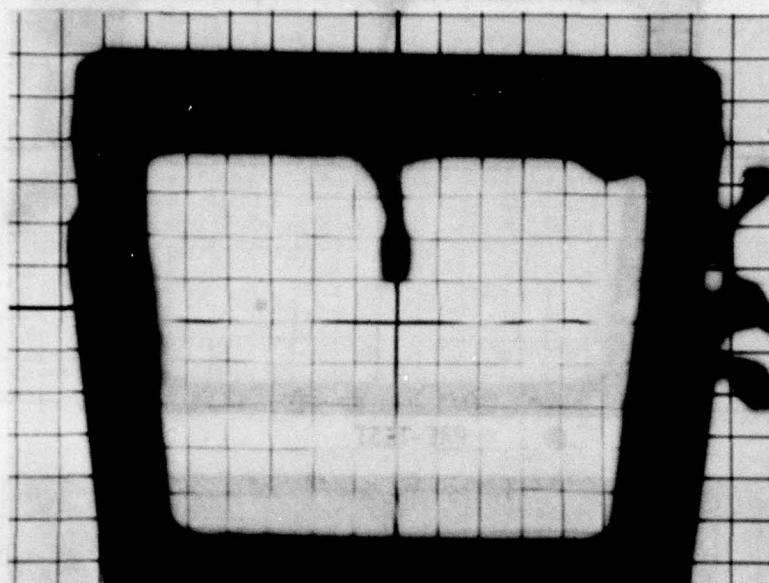
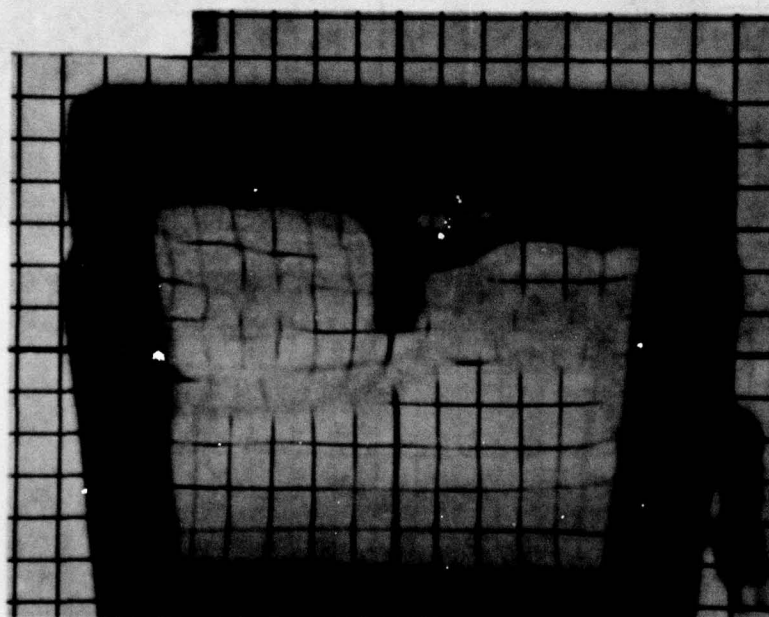
Figure 60. Grid Board Photos for Specimen GY01.

Figures 60 through 64 show grid board photos of the five specimens taken before testing and at the test completion. Overlays of pre-test and post-test photos are also shown for GY02 through GY05. All five specimens show distortion and loss of line clarity at the edges. There is slight line displacement visible in the photo overlays.

SPECIMEN	PHOTO TYPE	DESCRIPTION OF PHOTOS	DISPLACEMENT OF GRID LINES (INCHES)	
			HORIZONTAL LINES	VERTICAL LINES
GY01	PRETEST	Hazy spots. Abrasion spot in center (Ref 9)		
	POST-TEST M2.6	Delamination upper half Lines wavy and distorted	No overlay Shifted down	Shifted in.
GY02	PRETEST	Good clarity. Abrasion spot in center (Ref 9)		
	POST-TEST M2.6	Distortion at edges Lines clear	Shifted up slightly Bowed down 0.18 max.	No displacement Bowed in at sides 0.06
GY03	PRETEST	Hazy spots. Abrasion spot in center (Ref 9)		
	POST-TEST M2.4	Lines obscure at edges Lines clear	Shifted up 0.06 max. Bowed down 0.12 max.	Slight displacement Rotated out at top, in at bottom.
	M2.6	Lines distorted at sides	Bowed down 0.25 max.	Rotated out at top, in at bottom.
GY04	PRETEST	Good clarity		
	POST-TEST M2.4	Lines obscure at edges Lines distorted at sides	Shifted up 0.06 Bowed down 0.25 max.	Rotated out at sides 0.06 Rotated out at top, in at bottom

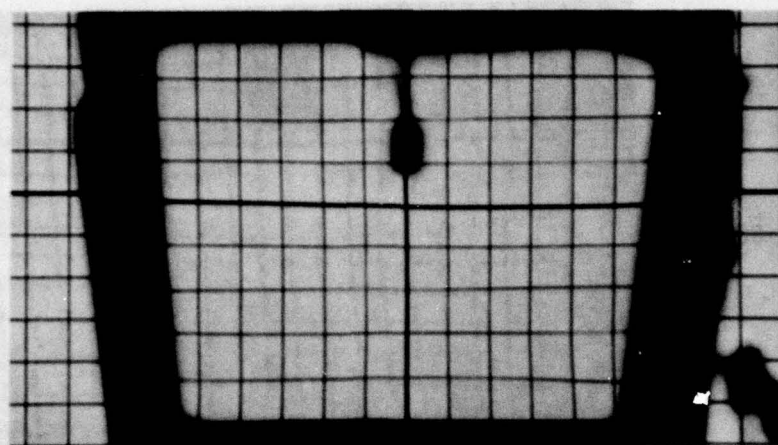
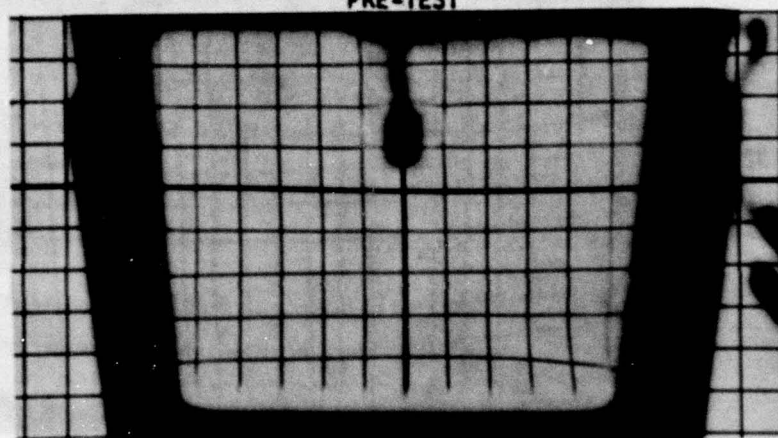
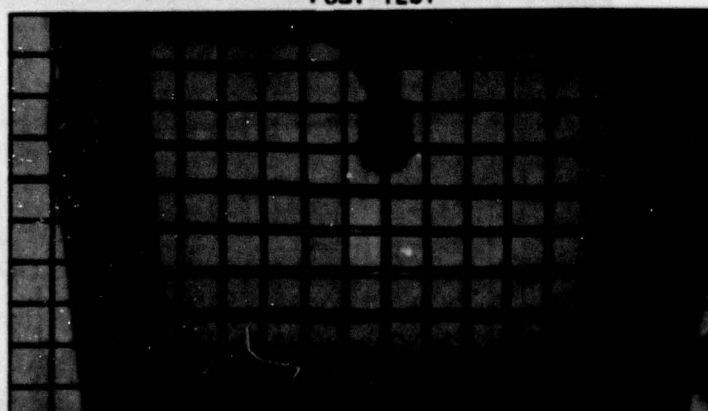
Figure 64. Grid Board Photos for Specimen GY05.

M3.0	Lines bowed. Severe distortion at sides	Bowed down 0.25 max.	Rotated out at top, in at bottom.
GY05	PRETEST	Good clarity		
	POST-TEST	Lines blank at lower edge	Shifted up 0.12 max.	No displacement.
	M2.4	Lines clear and continuous	Bowed down 0.18 max.	Rotated out at top, in at bottom.
	M3.0	Lines clear but bowed	Bowed down 0.25 max.	Rotated out at top, in at bottom.

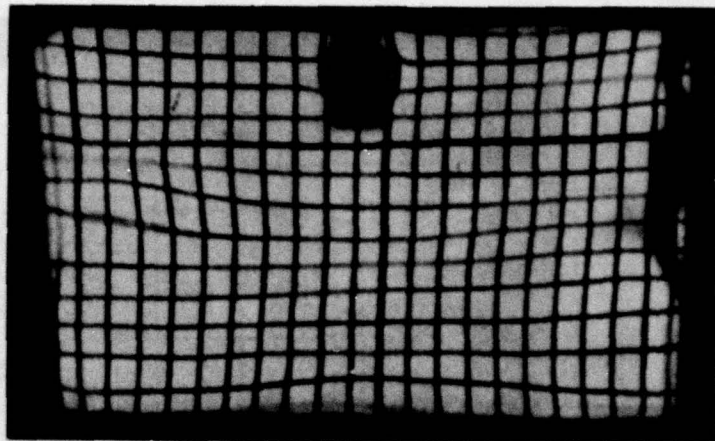
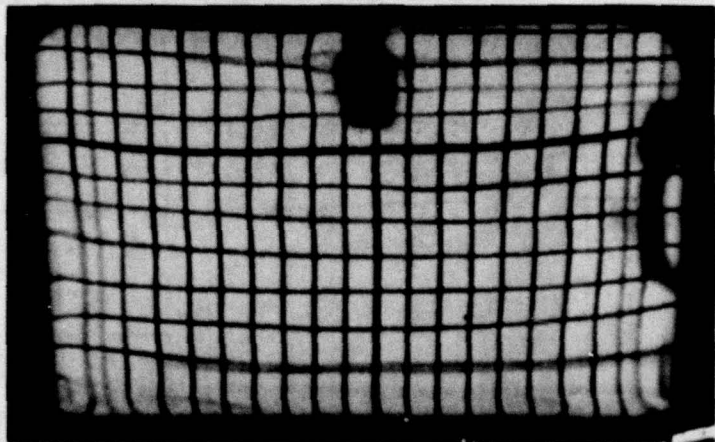
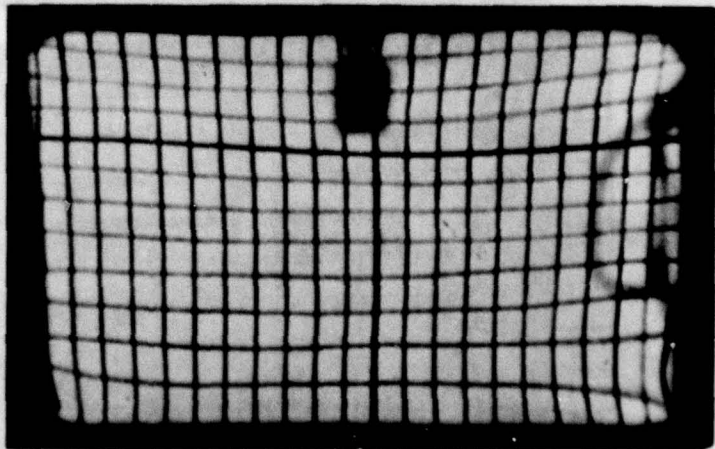
Figure 65. Tunnel Photos for Specimens GY03, GY04 and GY05 at Mach 2.4 (10-Minute Injection).

Figure 65 presents the final tunnel grid line photos for the 10-minute injections of GY03, GY04 and GY05 at Mach 2.4. Figure 66 displays overlays for the same injections. The dark oval spots in the GY03 overlay (Figure 66) is not visible in the final tunnel photo (Figure 65). This area was abraded with salt (Reference 9). The photos indicate consistent distortion for the three specimens. The maximum horizontal line displacement is approximately 0.20 inch for each specimen.

Specimens GY03, GY04 and GY05 withstood the Mach 2.4 environment very well. The lines were clear and dark (Figure 65). GY04 displayed some distortion along the sides. Generally, the horizontal line displacement (Figure 66) did not exceed 0.12 inch.

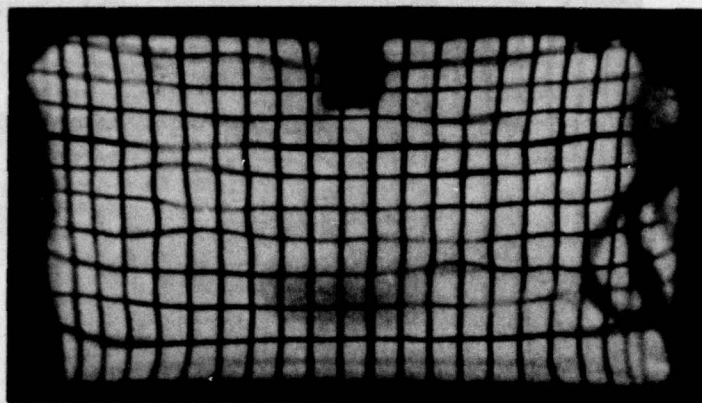
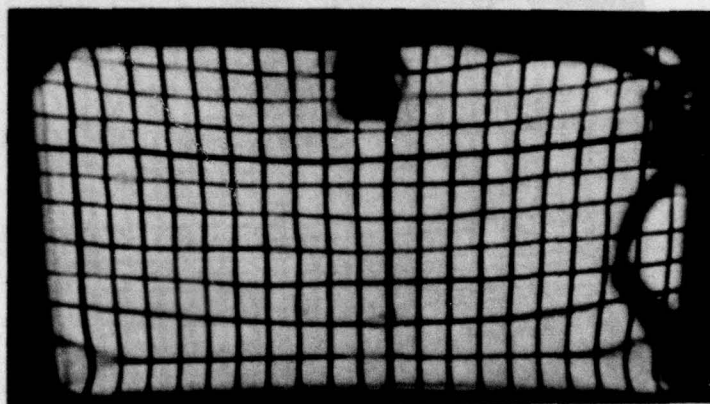
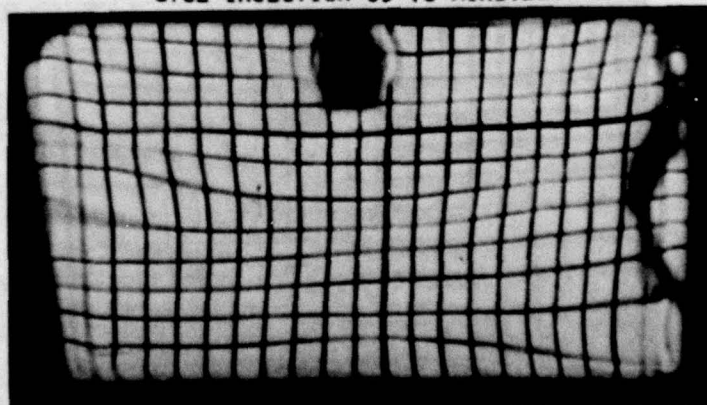
Figure 67. Tunnel Photos for Specimens GY01, GY02 and GY03 at Mach 2.6.

Photos and overlays are presented in Figures 67 and 68 for Specimens GY01, GY02 and GY03 at Mach 2.6. These injections were five minutes for Specimens GY01 and GY02, and 10 minutes for GY03. The oval spots in the photos for GY01 and GY02 resulted from salt abrasion (Reference 9). Specimen GY02 displays the least severe line distortion among the three specimens. Maximum line displacement approaches 0.25 inch for GY03.

Specimens GY01 and GY02 and GY03 are potential windshield candidates for a Mach 2.6 environment. The tunnel photos (Figures 67 and 68) are for 5-minute injections since Specimen GY01 and GY02 delaminated at the termination of their 10-minute injections. GY03 survived. It sustained some distortion and the displacement of the horizontal lines was 0.25 inch maximum.

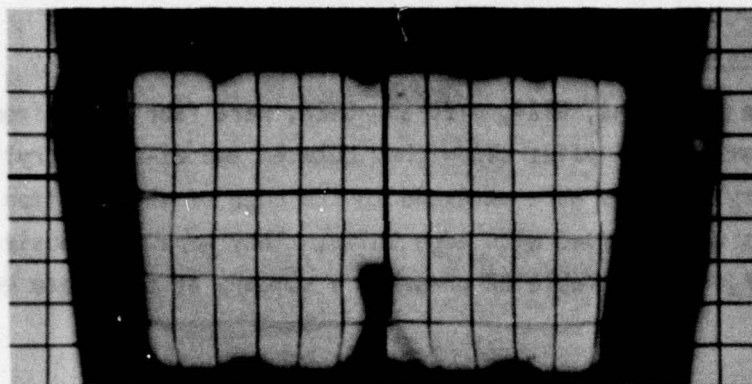
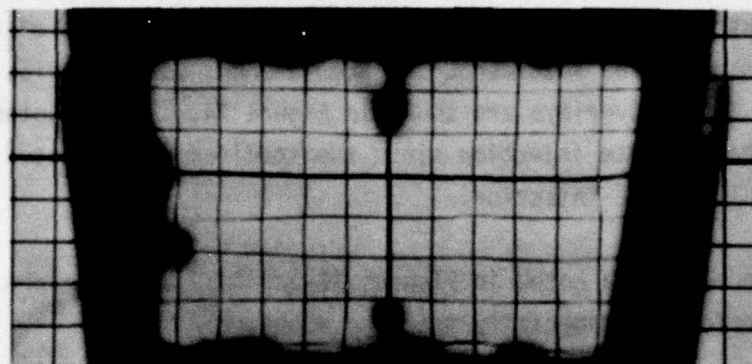
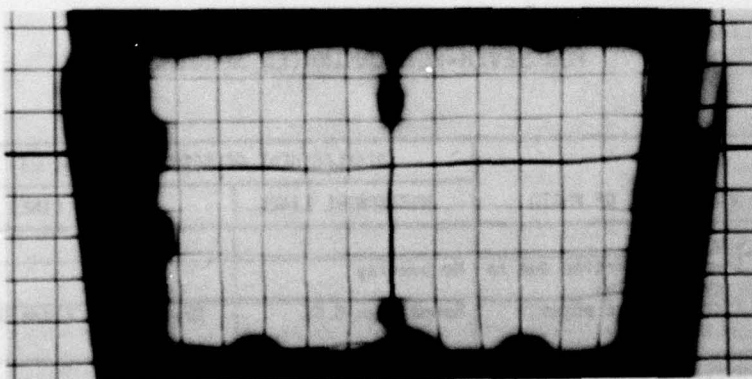
Figure 71. Pre-Test Grid Board Photos for Specimens GY24, GY25 and GY26.

Pre-test and post-test grid board photos are shown in Figures 71 and 72 for Specimens GY24 and GY26. Overlays were not made because of the severity of damage to the specimens. Figure 73 shows tunnel photos for GY24, GY25 and GY26. Overlays are shown in Figure 74. These photos were taken during the 5-minute injection since the specimens delaminated during the subsequent 10-minute injection.

SPECIMEN	PHOTO TYPE	DESCRIPTION OF PHOTO	DISPLACEMENT OF GRID LINES (INCHES)	
			HORIZONTAL LINES	VERTICAL LINES
GY24	PRETEST	Hazy spots		
	POST-TEST	Severe distortion due to delamination	No overlay	
	M2.4	Distortion at edges. Lines wavy.	Bowed down 0.06	Bowed in at sides 0.06
GY25	PRETEST	Hazy spots		
	POST-TEST	Delamination lower half Distortion at edges	No overlay	
	M2.4	Distortion at edges Lines wavy.	Bowed down 0.06	Bowed in at sides 0.06
GY26	PRETEST	Hazy spots		
	POST-TEST	Delamination lower half Distortion at edges.	No overlay	
	M2.4	Distortion at edges and in center.	Bowed down 0.06	Bowed in at sides 0.06

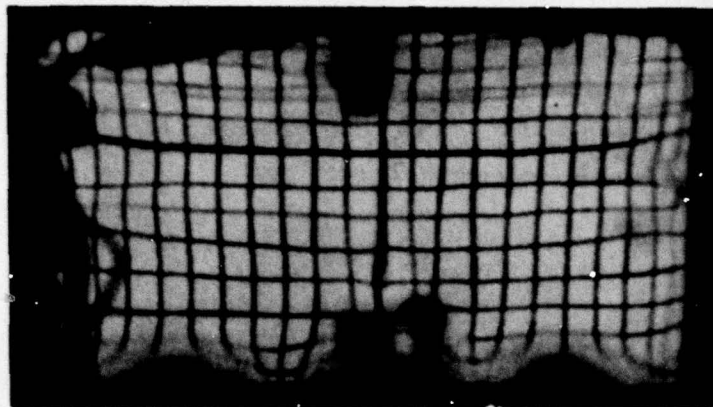
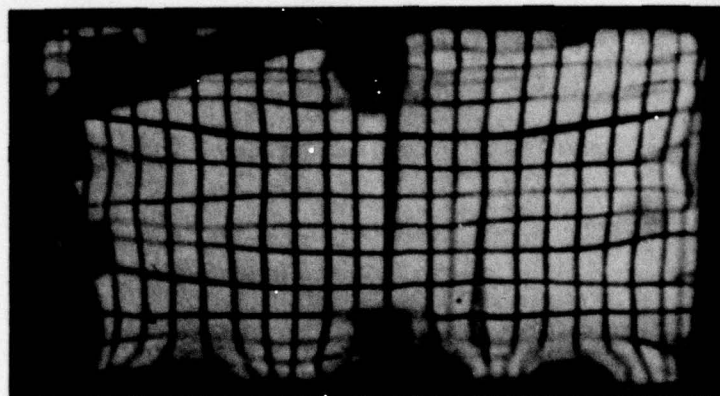
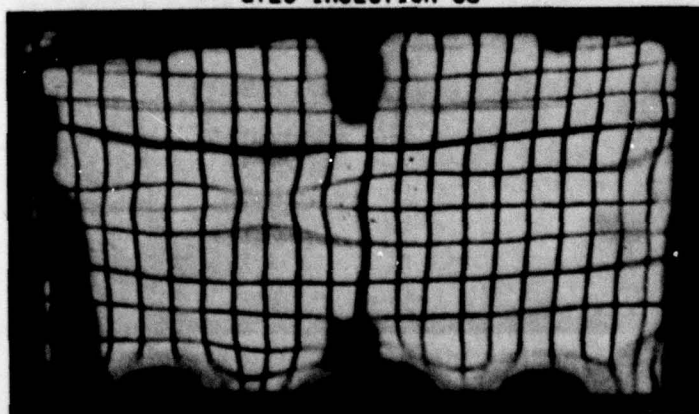
Figure 73. Tunnel Photos for Specimens GY24, GY25 and GY26 at Mach 2.4 (5-Minute Injection).

Line displacement, as noted in Figures 73 and 74, is not severe, but the lines are deformed, especially near the edges.

Specimens GY24, GY25 and GY26 experienced small line displacement after their initial 5-minute injections, but the lines became irregular and distorted (Figures 73 and 74). The distortion along the lower edge of each specimen was due to the projection of the edge bolts into the field of vision at the 60 degree angle of incidence. The distortion would be less severe if these fasteners were removed. These three specimens failed by delamination of the exterior ply during this subsequent 10-minute injection. These specimens sustained comparatively large increases in haze.

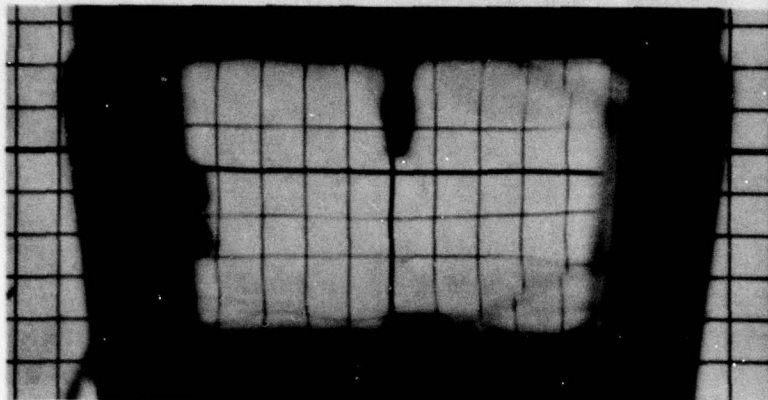
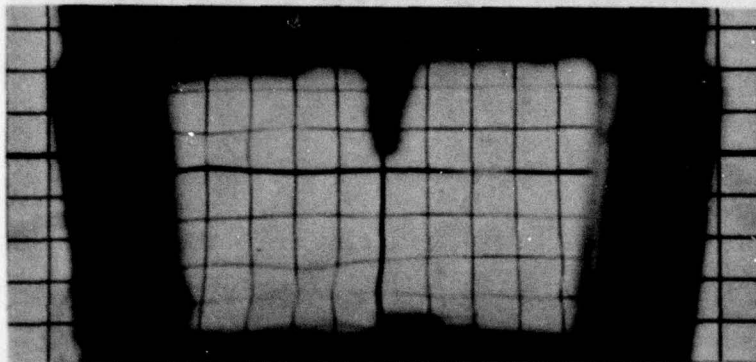
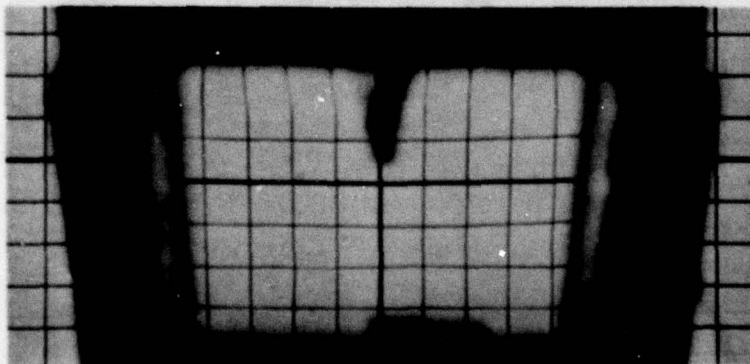
Figure 75. Pre-Test Grid Board Photos for Specimens GY21, GY22 and GY23.

Pre-test and post-test grid board photos are shown in Figures 75 and 76 for Specimen GY21, GY22 and GY23. These specimens exhibit hazy spots and indistinct lines on the pre-test photos. Specimen GY23 shows a definite loss of line clarity in its post-test photo.

SPECIMEN	PHOTO TYPE	DESCRIPTION OF PHOTO	DISPLACEMENT OF GRID LINES (INCHES)	
			HORIZONTAL LINES	VERTICAL LINES
GY21	PRETEST	Hazy spots		
	POST-TEST	Severe distortion due to delamination	No overlay	
	M2.4	Lines distorted due to cracks	No overlay	
GY22	PRETEST	Hazy spots and wavy lines		
	POST-TEST	Severe distortion due to delamination	No overlay	
	M2.6	Distortion due to delamination	No overlay	
GY23	PRETEST	Hazy spots		
	POST-TEST	Lines obscure. Poor light transmission	No overlay	
	M3.0	Line distortion and poor line intensity	No overlay

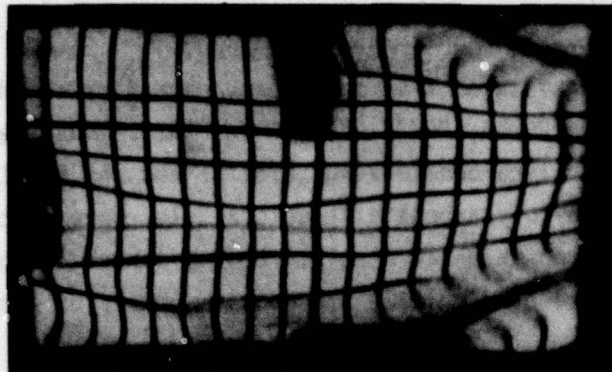
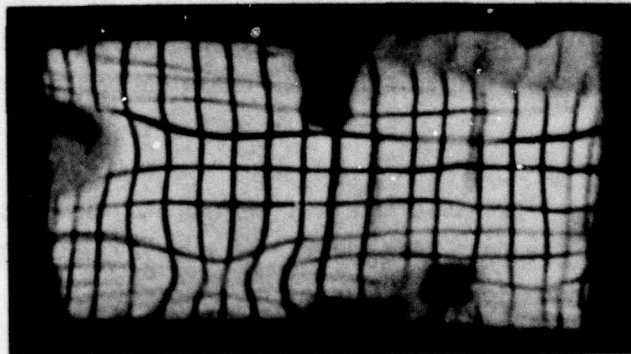
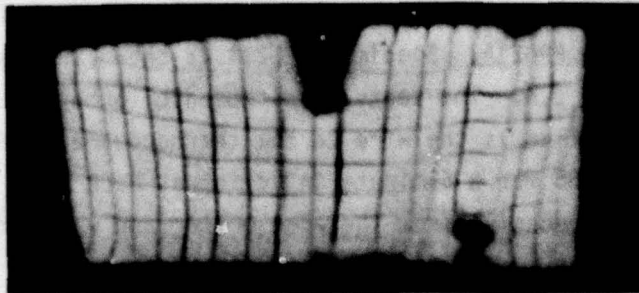
Figure 77. Tunnel Photos for Specimens GY21, GY22 and GY23.

Figure 77 shows a tunnel photo for Specimen GY21 at Mach 2.4, GY22 at Mach 2.6 and GY23 at Mach 3.0. The photo of GY21 shows severe distortion due to cracks in the face ply. The distortion in the photo of GY22 is due to face ply delamination. The photo of GY23 shows poor line intensity and line distortion. The overlays for Specimen GY21, GY22 and GY23 were not clear.

Specimen GY21 experienced severe delamination (Figures 86 and 77) which was precipitated by cracks in the face ply that occurred during fabrication.

The poor optics for Specimen GY22 was caused by face ply delamination (Figure 77). The delamination was precipitated by a rupture in the rabbeted section of the face ply. This configuration would require a redesigned edge to be considered as a potential Mach 2.6 windshields.

Specimen GY23 became very cloudy and vision through this configuration was severely degraded. The face ply material became rough.

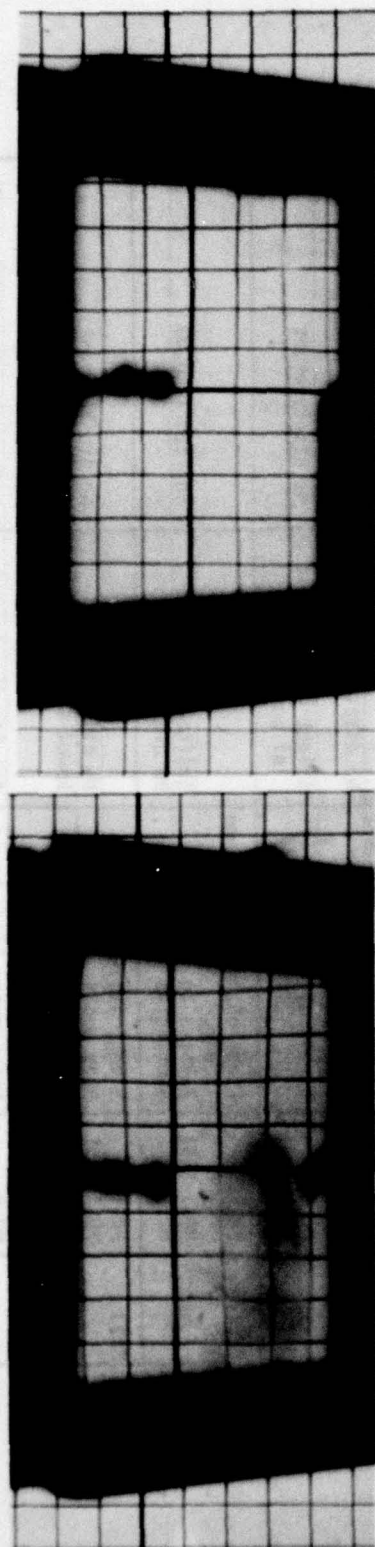
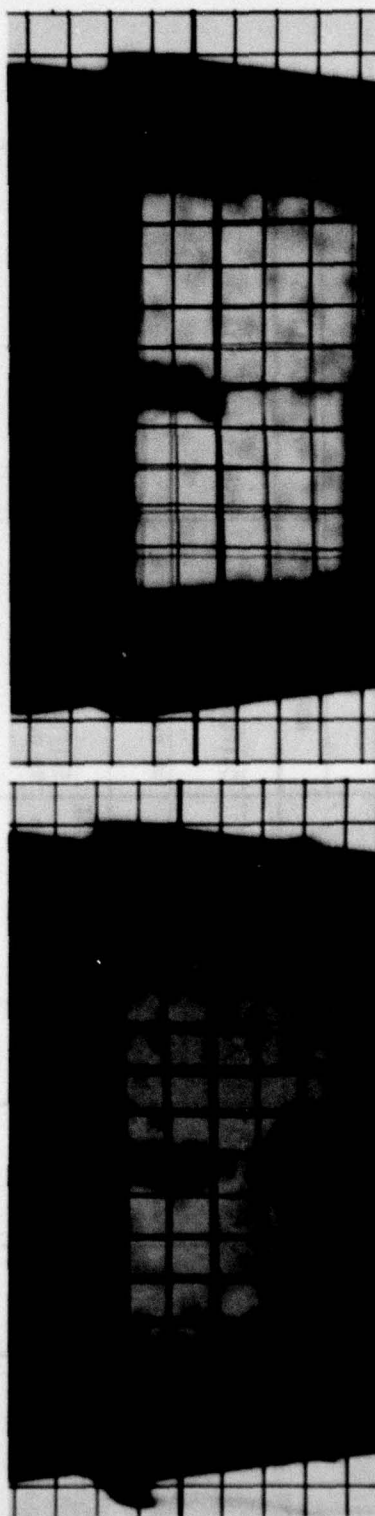
Figure 78. Grid Board Photos for Specimen PG21. Figure 79. Grid Board Photos for Specimen PG21A.

Figure 78, 79, 80 and 81 show pre-test grid board photos and overlay photos for Specimens PPG21, PPG21A, PPG22 and PPG22A. The spots in the overlay photos resulted from interlayer bubbling. An overlay photo of PPG22 is not shown since it did not experience line displacement or distortion. The spot visible in Figure 78 was caused by a defect in the interlayer.

SPECIMEN	PHOTO TYPE	DESCRIPTION OF PHOTO	DISPLACEMENT OF GRID LINES (INCHES)	
			HORIZONTAL LINES	VERTICAL LINES
PPG21	PRETEST POST-TEST	Hazy spot Lines straight. Spots due to bubbles in interlayer.	Shifted up 0.12 max.	Shifted in 0.12 max.
	M2.4	Bubbles in interlayer. Hazy spot	No overlay.	
PPG21A	PRETEST POST-TEST	Lines clear and straight Bubbles in interlayer Complete loss of vision due to bubbles in interlayer	Shifted up 0.06 No overlay	Shifted in 0.12 max.
	M3.0			
PPG22	PRETEST POST-TEST	Lines clear and straight Streak of adhesive on outer surface	No displacement	No displacement
	M2.4	Streak of adhesive	Slight displacement of one line.	No displacement
PPG22A	PRETEST POST-TEST	Lines obscure at extreme edge. Bubbles in interlayer	Shifted down 0.10 No overlay	Shifted in 0.03
	M2.6	Bubbles in interlayer		
SK23	PRETEST POST-TEST	Slight haziness Hazy spots Spots due to adhesive from edge spacer.	No displacement Bowed down 0.12 max.	No displacement Sides rotated out 0.18 max.

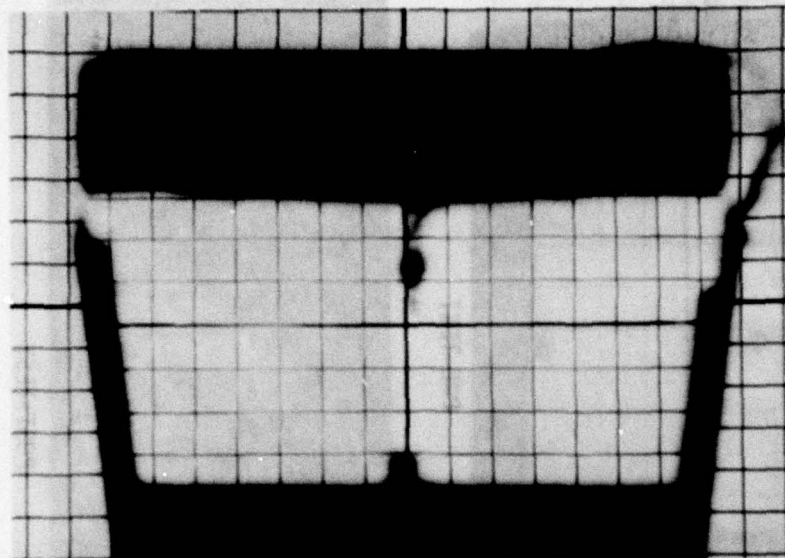
Figure 82. Grid Board Photos for Specimen SK23.

Figure 82 shows a pre-test and post-test photo for Specimen SK23. Haze is visible in the post-test photo. No overlay of SK23 is shown since it did not experience line displacement or distortion.

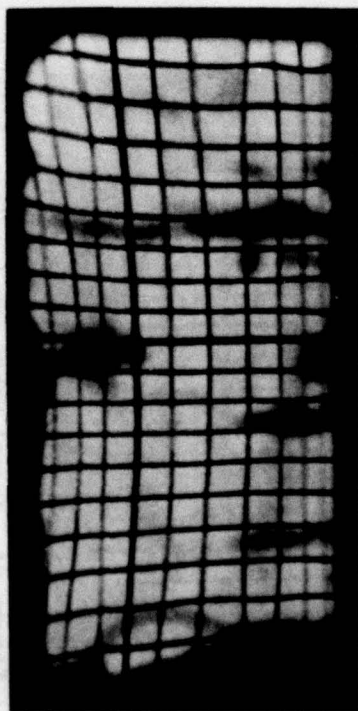
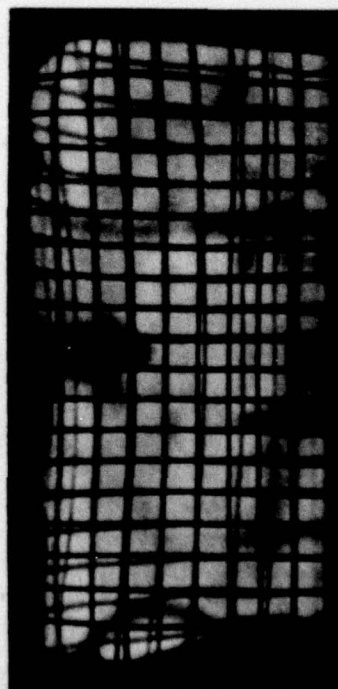
Figure 86. Tunnel Photo and Overlay for Specimens SK23 at Mach 2.6 (Injection 56, 10 Minutes).

Specimen SK23 is shown in Figure 86 at Mach 2.6 and Figure 87 at Mach 3.0. The spots in Figure 86 were caused by adhesive from the edge member. SK23 displays less line distortion at Mach 2.6 than at Mach 3.0. The haze visible in Figure 87 is also present in Figure 82.

Specimen SK23 sustained severe rotation of the vertical lines at the upper corners (Figure 86). The spots in the photo were caused by

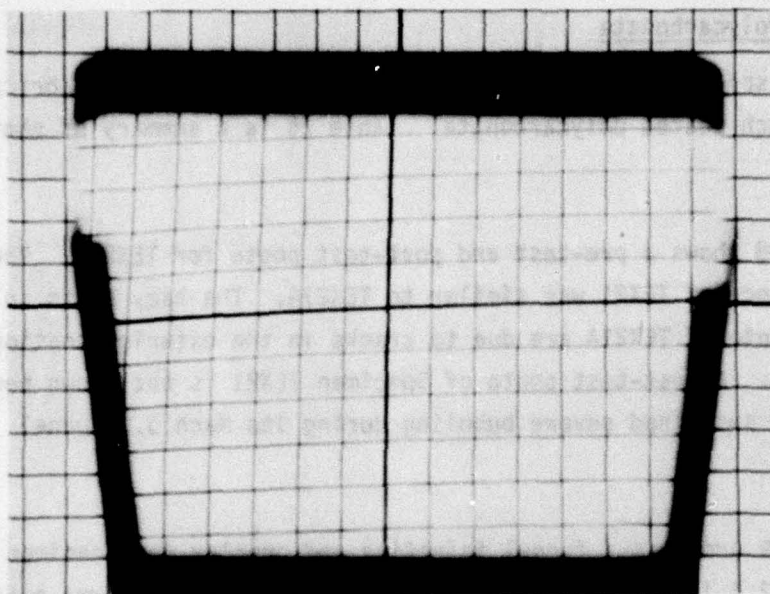
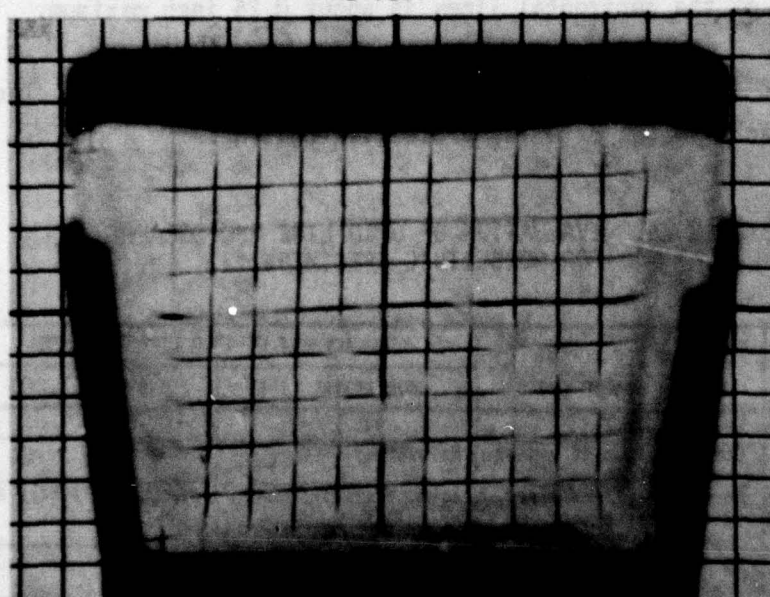
Figure 88. Grid Board Photos for Specimen TEX21A.

Figure 88 shows a pre-test and post-test photo for TEX21A. The pre-test appearance of TEX21 was similar to TEX21A. The hazy spots in the post-test photo of TEX21A are due to cracks in the exterior coating on the specimen. A post-test photo of Specimen TEX21 is not shown because the specimen sustained severe bubbling during its Mach 3.0 tunnel injection.

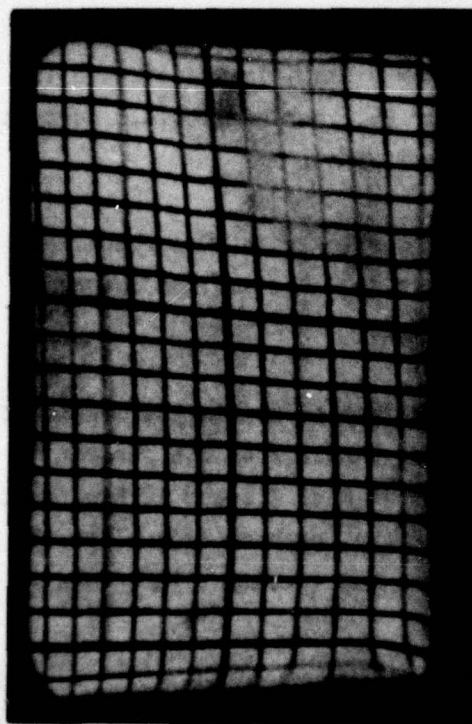
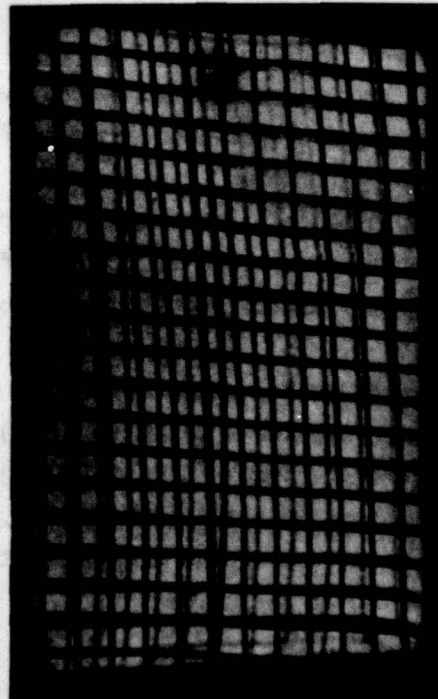
Figure 89. Tunnel Photo and Overlay for Specimen TEX21 at Mach 2.4 (Injection 28, 10 Minutes).

Figure 89 presents a tunnel injection and overlay for Specimen TEX21 at the Mach 2.4 injection. Haze is obvious in the right lower quadrant. Displacement of the horizontal lines is about 0.25 inch maximum.

Specimen TEX21 survived a 10-minute injection in good shape. The lines were clear and dark except for a spot of haze (Figure 89). The displacement of the horizontal lines approaches 0.25 inch.

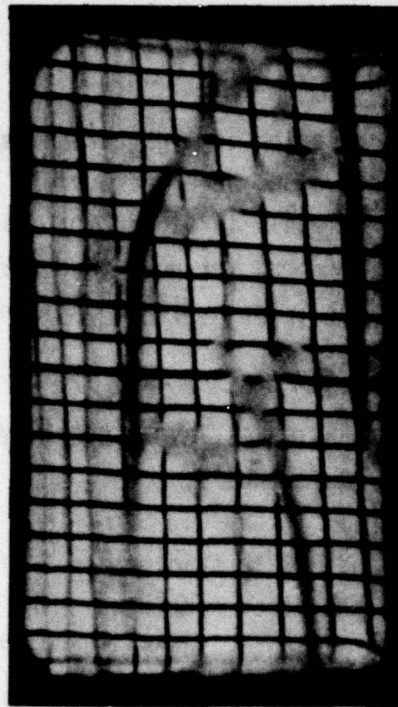
Figure 90. Tunnel Photo for Specimen TEX21A at Mach 2.6 (Injection 65, 5 Minutes).

Figure 90 is a tunnel photo of Specimen TEX21A at Mach 2.6. The lines are cracks in the exterior protective coating.

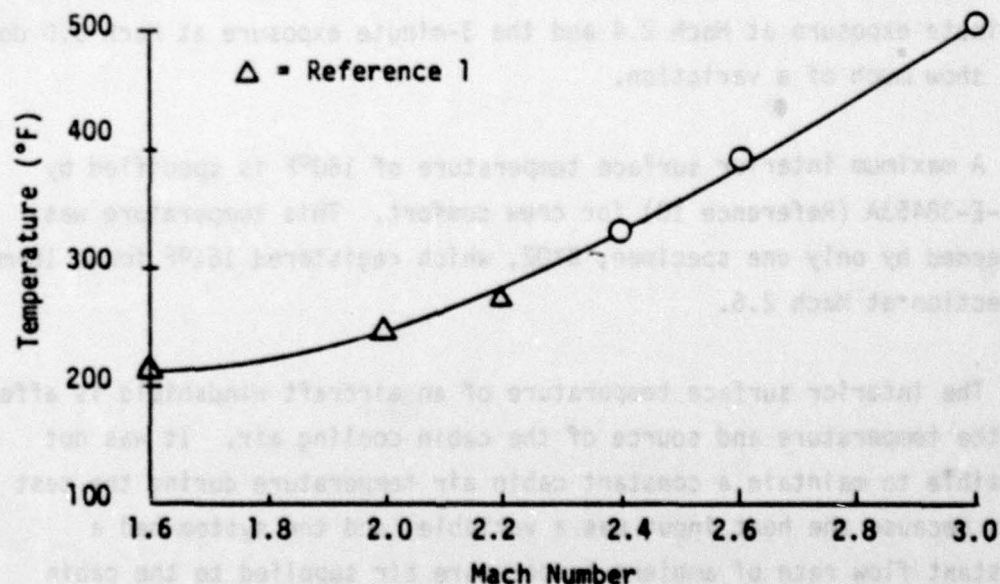
Figure 100. Average Maximum Surface Temperature Versus Mach Number.

These calculated temperatures are 7, 8 and 11 percent higher than the test temperatures recorded at Mach 2.4, 2.6 and 3.0 and the differences are attributed to discrepancies in the material properties used in the analysis. These results are consistent with the data presented in Reference 1 which reported higher calculated temperatures than test temperatures. The average test temperatures are plotted in Figure 100, together with the temperatures from Reference 1 for Mach 1.6, 2.0 and 2.2. The curve indicates an increase in the temperature/velocity ratio as the Mach number rises and is consistent with the theory.
